# *Lead-free Wave Soldering Process Issues*

***Bob Willis***

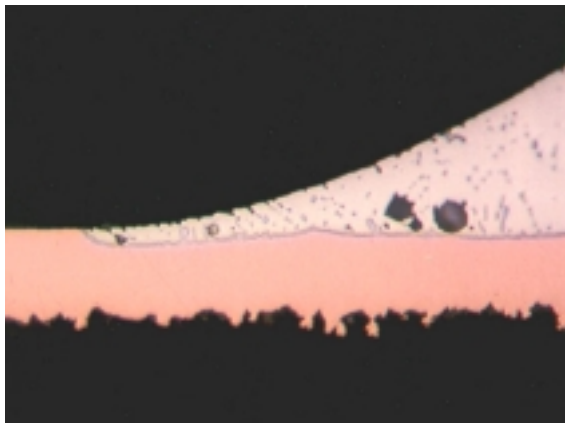
Example microsection produced as part of the evaluation showing copper erosion on the copper track. (IDEALS Lead Free Project)

Although examples of copper erosion have been highlighted in the industry there is little evidence to date of this being an issue. In the case of single sided boards the apparent erosion may have been due to preparation of the copper for OSP treatment. In this case copper is mildly etched, excessive prep may have removed more copper around the pads as other areas of the tracking would be protected by the solder mask. Where mechanical cleaning is used and incorrectly controlled the copper can be reduced around the hole leading to a apparent copper reduction. Further investigation of the problem and the examples circulated in the industry will be further reviewed and where appropriate further trials conducted.

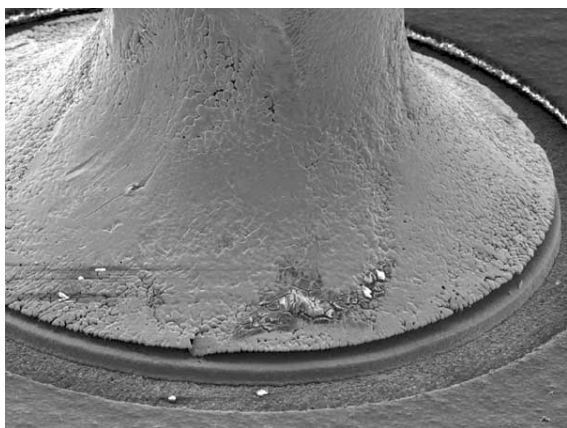
Figure shows the fillet lifting on the topside of the joint

Microsection examination showed evidence of the same three fillet issues seen during visual inspection, the fillet phenomena has been discussed in detail in other articles. The soldering quality to the plated through hole and pins were all found to be satisfactory.

Environmental trials have been conducted on joints with fillet lifting and pad lifting by NPL during another lead-free project. The testing on boards involved temperature cycling between +125/-55° for over 2000 cycles. There was no evidence of solder joint failure on any of the samples tested. More recently testing has been covered in a report published by Epson Electronics on lead-free assembly. One section also looked at lead-free joints featuring fillet lifting and pad lift. Testing by Epson engineering staff demonstrated that again failure of joints did not occur even with these defects.

During the SMART Group Lead-free trip to Japan the issue of fillet lifting was discussed. Most companies were of the opinion that it did not have an impact on reliability. Only evidence of pad lifting was considered an issue as it could, in theory, lead to breaking of inter-connecting tracks. To date the author has not seen any evidence of this from any source.

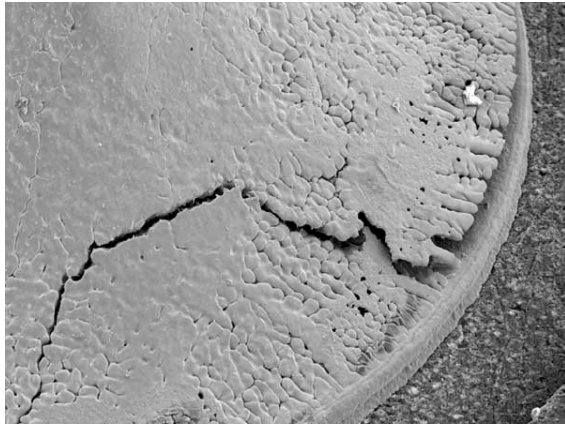
Figure 6 shows evidence of fillet tearing

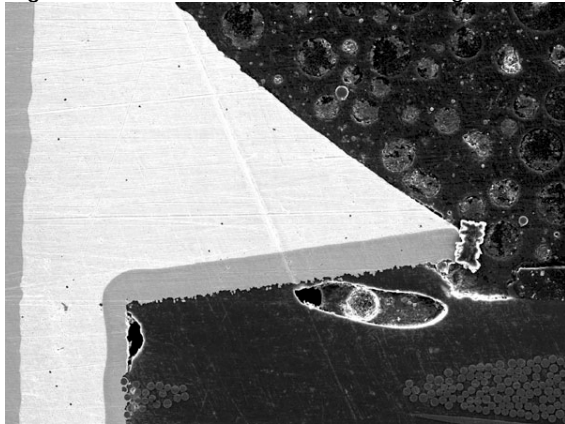
Figure shows pad lifting from the surface of the laminate on a microsection
