Bob Willis

A PCB defects guide

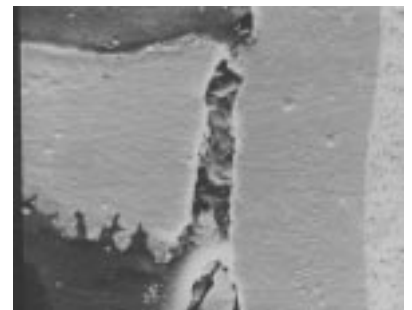
Figure 2: Inner-layer separation occurs when de-smearing, a cleaning process, is not properly conducted.

Another defect that arises due to thermal stress is inner-layer separation in multilayer boards (**figure 2**). This happens whenever the adhesion of the copper through-hole plating is not sound. Make sure that the through-hole is properly cleaned prior to metallization to avoid this problem.

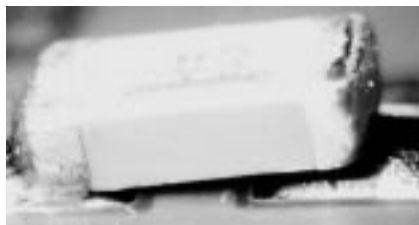
Figure 3: The component has lifted because of the thick solder mask; during reflow it acted like a fulcrum lifting the part just above the pad surface.

Component movement and lifting (**figure 3**) are related to the soldering process and design of the board. If one termination reflows and wets before the other, surface movement is generated—rotational or vertical. Different solderabilities of the two terminations also cause this problem.

The use of vapor-phase reflow is more likely to cause movement than convection because of the fluid movement on the board surface. The incidence of component lift is increasing due to the increased reduction in the size of passive parts.
